NEWSLETTER NUMBER 24

Summer 2006

EDITOR'S REPORT <i>Ann Adams</i>	3
SCANTLE SLATING at ADDISLADE FARMHOUSE DEAN PRIOR, DEVON <i>Terry Hughes</i>	4
A SOURCE of INFORMATION about FARM BUILDINGS <i>Jo Cox</i>	13
THE SIDWELL STREET METHODIST CHURCH, EXETER <i>Roger Thorne & Jo Cox</i>	20
DBG NEWS	25

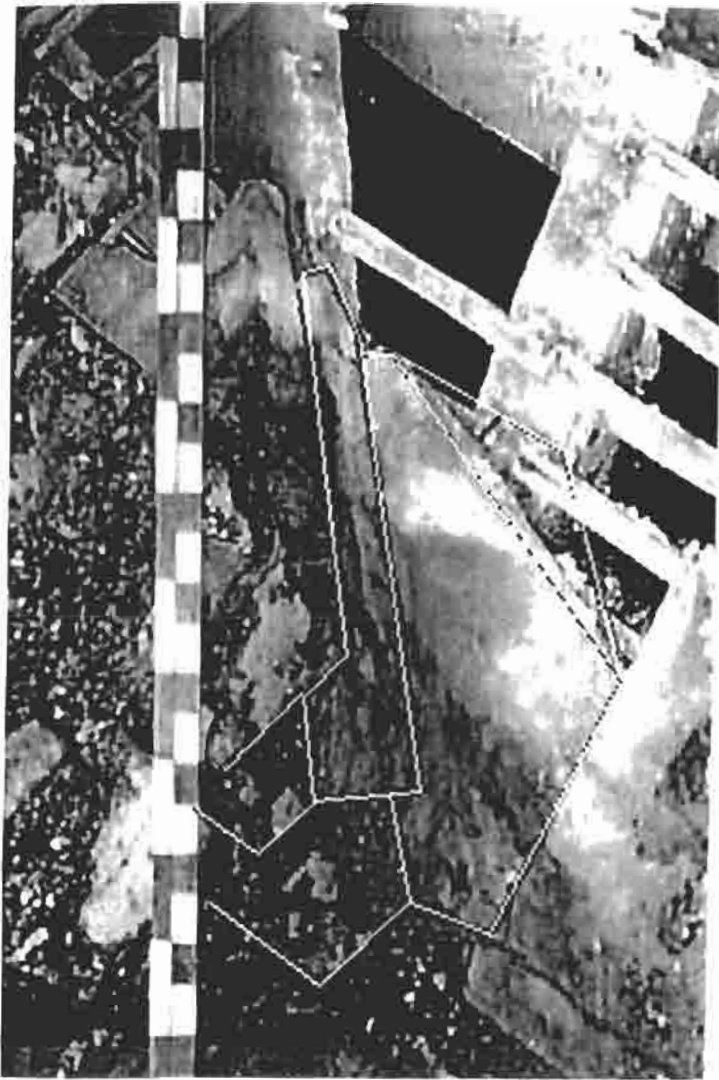
Fig 7. Arrangement of the valley slating, with the edges of the slates shown in broken line. The outlined slate on the right is very heavily shouldered. The white line shows the more normal shape

The valley indicated in Figure 1 was stripped sequentially to determine how the slates were laid together to make it watertight. The dormer slating to the left of the valley was found to be substantially undisturbed and was constructed in triple lap, in the same way as the slope described above. In contrast, the slope to the right did not course consistently and appears to have been reconstructed, using the original laths but without correctly head-lapping the slates. This presented considerable difficulty in unravelling the original construction. However, by careful inspection and by manipulating the photographic images, it was possible to reach the conclusion that the valley is quite simply laid out, as illustrated in Figures 7 and 8.

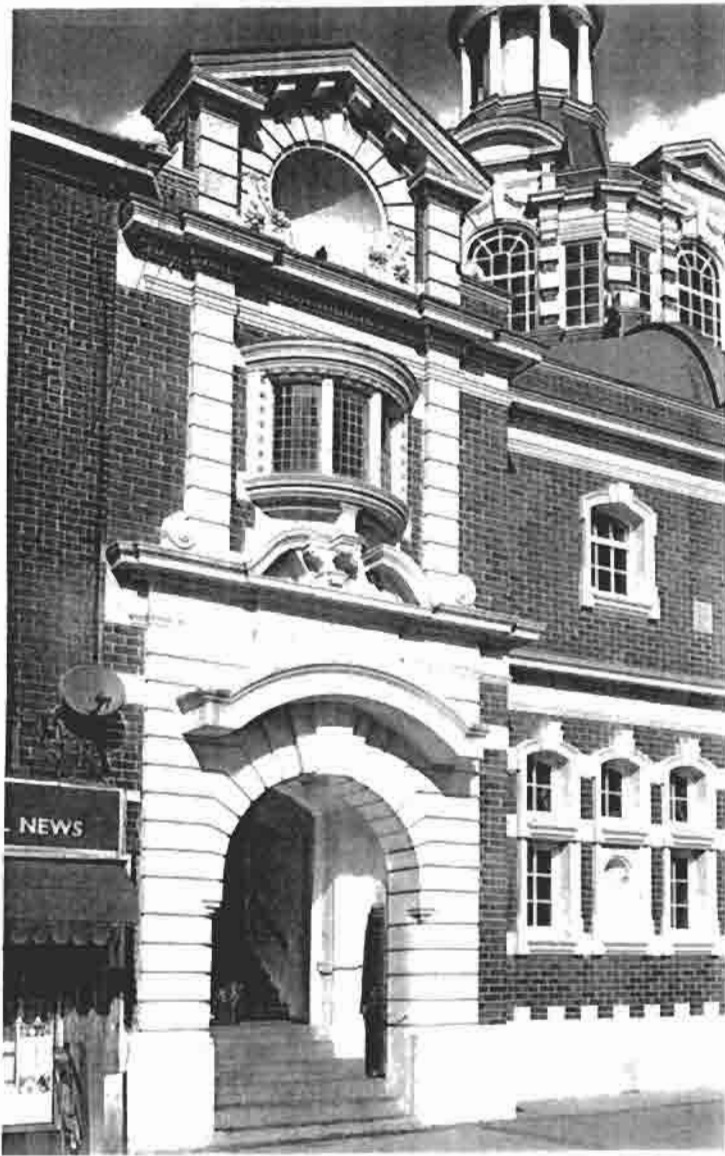
Fig 1. The restored façade on Sidwell Street; the elegant concrete mouldings re-secured

penetration in the cone of the pepper-pot, which has now been covered in copper. The large concrete mouldings had degraded and the worst sections have been repaired and dowelled into the original, with stainless steel dowels, and the concrete finished with a sacrificial coat, which will need regular re-application. The restored exterior is now a splendid element in the otherwise rather tatty Sidwell Street, and the City Council is to be commended for having moved the bus stop outside, to give a full view of the building.
